STUDENT CONTEST 2019

Camborne School of Mines

Tremough Campus Survey

D. Anderson, J. Heslington, T. Wilkie

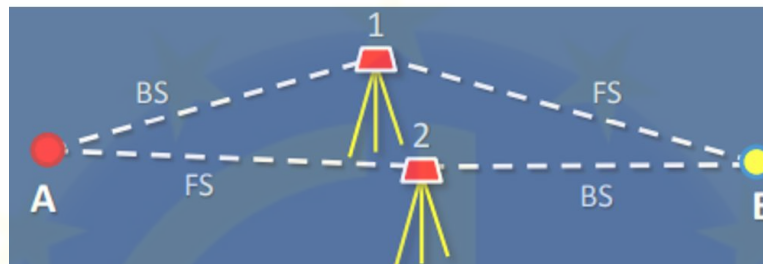
Figure 2: Shows a typical double set levelling position (Image courtesy of ELE)

Double set levelling was used in order to minimise error in the data. If error was identified, the set was repeated again in order to eliminate the error. The green colouring shows that the error is acceptable and the run can carry on to the next station. The yellow colouring shows the station levels. This ensures the highest accuracy of results. The circuit around the stations was closed with 000 mm error, which was allowable when compared to our allowable misclosure (*see below*).

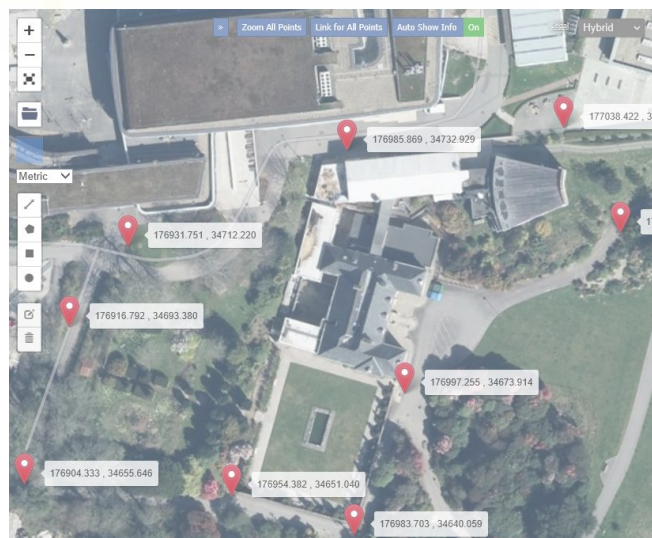
Figure 3: Locations of total coordinates in relation to traverse. [gridreferencefinder.com]
